Heron Lake State Dam Visit

On September 22, 2016, the board of managers and staff visited the Heron Lake State Dam. Randy Markl explained how the hydrology of the Heron Lake system works, provided an historical overview of the dam, and described the management procedures for the structure.

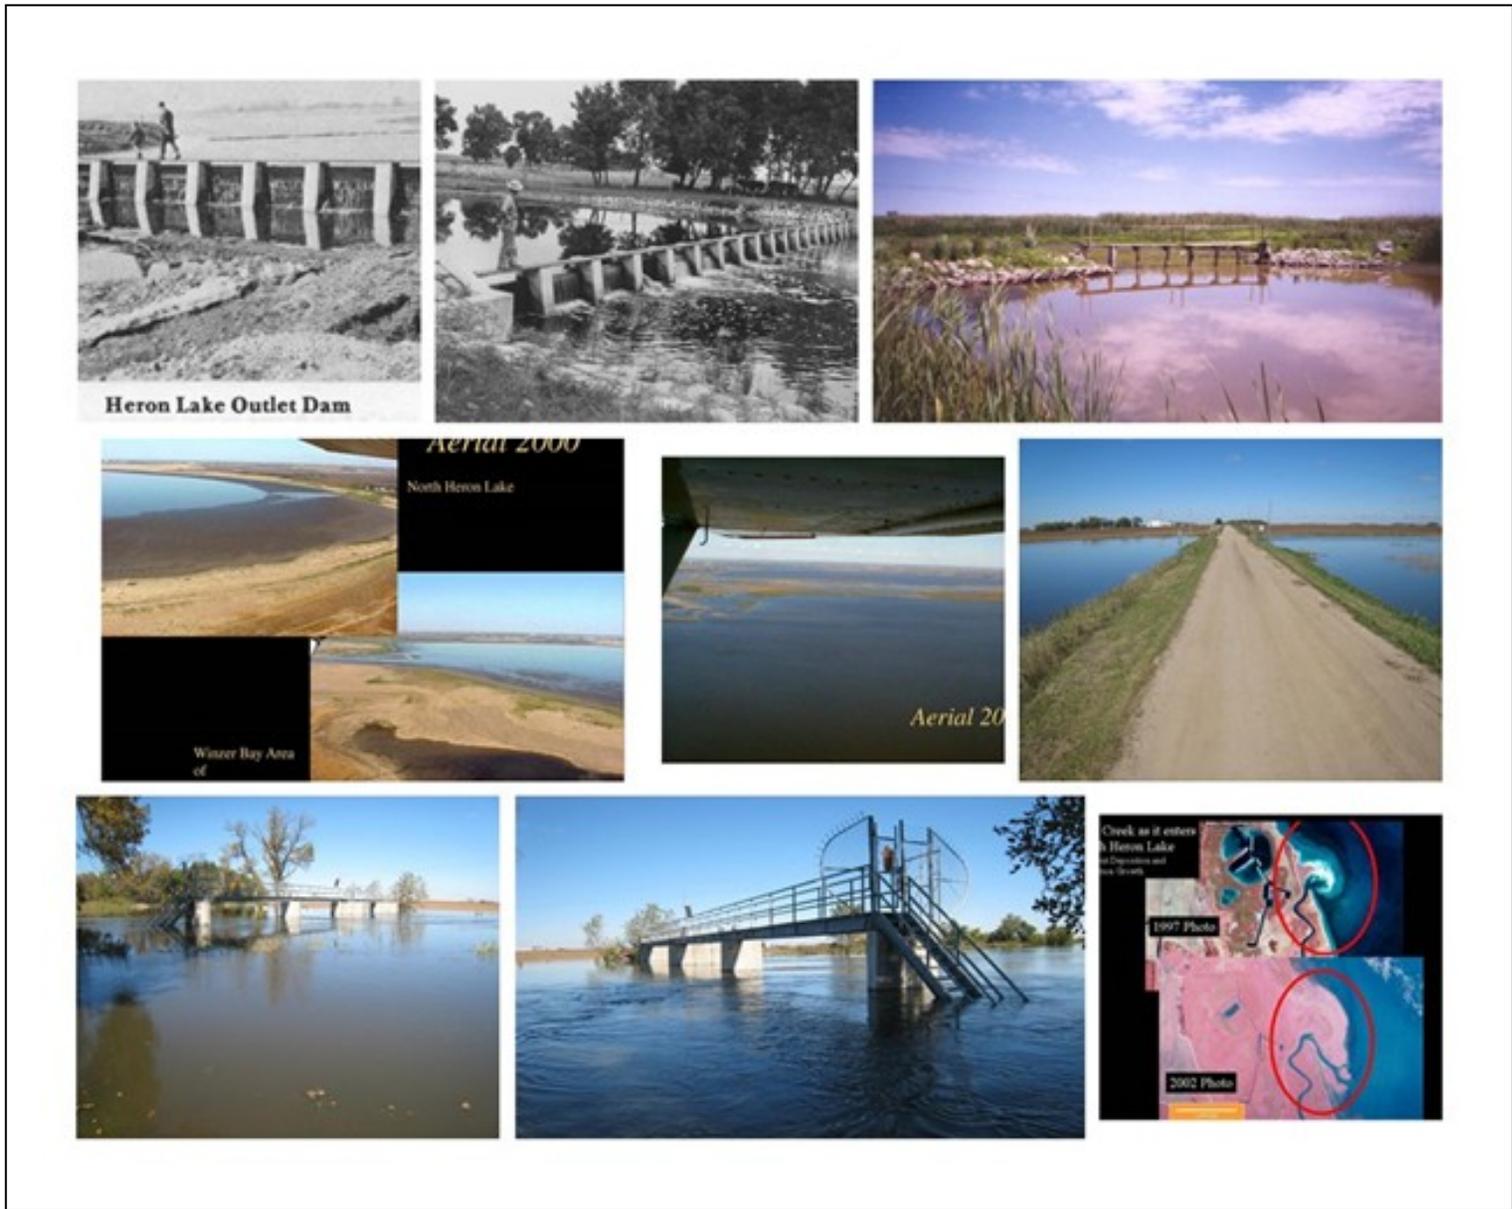
Photos (left to right, top to bottom): Heron Lake Dam late 1937 or early 1938; Heron Lake Dam – 1941; Dalziel Dam - 1998; Heron Lake aerial – 2000; Heron Lake aerial - 2001; HLWD gaging station on the Heron Lake Outlet – 2010; Heron Lake Dam – 2010 (2 photos); Heron Lake sediment

- The **Works Progress Administration constructed the original State Dam** in 1937. Its main purpose was to conserve water after the drought years of the thirties.

- The **Dalziel Dam** was located in the channel downstream of North Heron Lake in the North Marsh. The stoplogs and rocks in the bays were removed in December of 1989 to aid in the total drawdown of Heron Lake. This dam was completely removed in the spring of 1999.

- **In 2006, the concrete weir of the State Dam was cut down again from 1400.2 to 1399.5.** This puts the dam at 3.3 feet high. It is only one foot higher than the runout elevation of South Heron and 1.5 feet higher than the runout elevation of North Heron.
